Virginia State Route 7 Video Detection System Performance Assessment

Prepared for:
Honorable Congressman Frank Wolf

Prepared by:
U.S. Department of Transportation
Federal Highway Administration

February 3, 2006

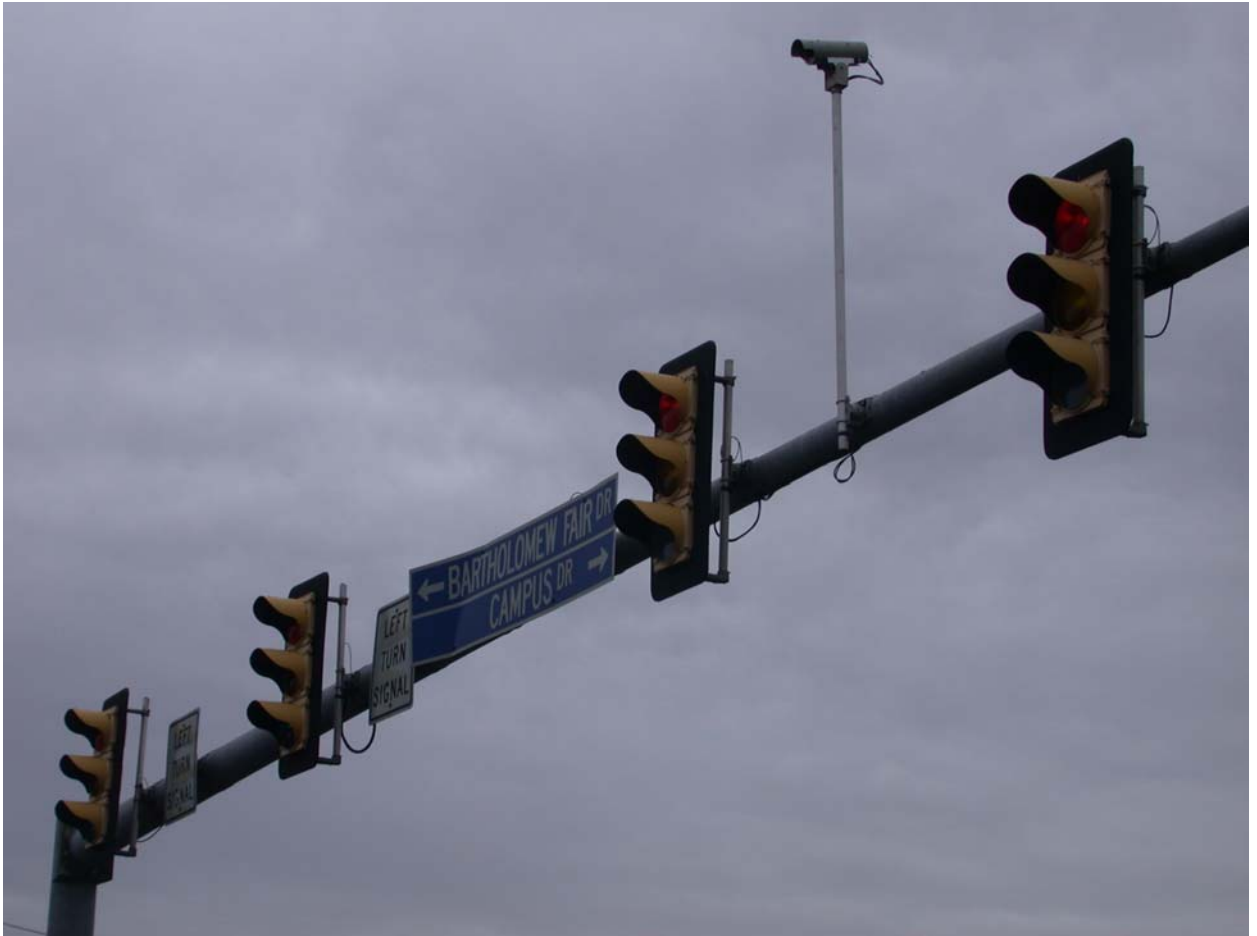
Figure 2: TYPICAL VIDS CAMERA INSTALLATION

The VIDS installation is fairly consistent throughout the study area. With few exceptions at strain pole signalized intersections, the cameras are mounted on the mast arms at the far side location with a seven-foot riser (Figure 2).

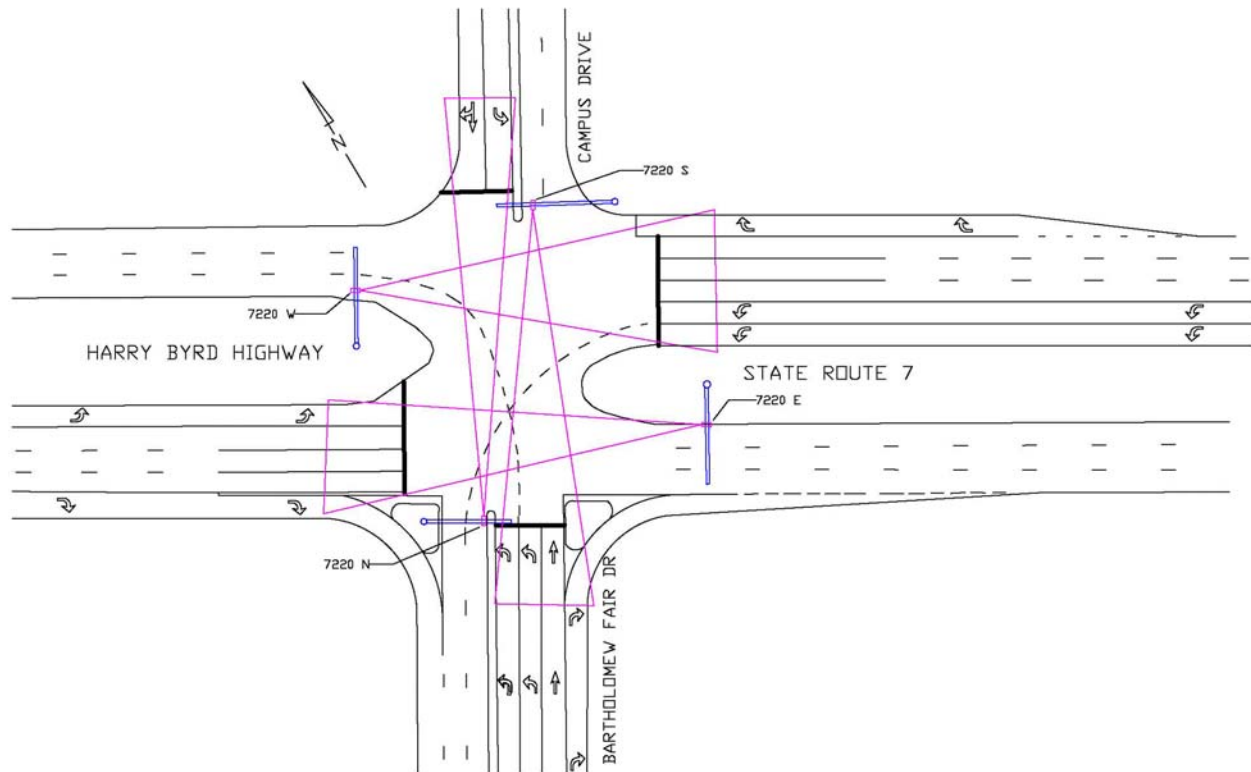
Figure 3: EXISTING VIDS CONFIGURATION

The VDOT technical staff, in concert with personnel from the equipment distributor and the installation contractor, performed the VIDS design. The design work consisted principally of field investigation and the identification of VIDS camera locations. The camera locations show lots of commonality, e.g., Route 7 cameras as well as side street cameras are all located on the far side of the approach as shown in Figure 3. The pink triangles show the current camera's view and angle. The number of VIDS and related intersections are indicated in Appendix A.

Analysis of the VIDS design showed several deficiencies. These findings are based on field evaluation of the VIDS system, lab analysis of captured video streams and discussion with the VDOT staff. Typically, a standard, all-purpose video camera should be used to record the view at the proposed VIDS location as part of the installation process. This analysis was not performed on a case-by-case basis for Route 7. Second, the VIDS camera locations show consistency regardless of the intersection geometry. Each camera is located on the far side of the approach. Again, camera location should have been analyzed on an intersection-by-intersection basis.

False and missed calls due to occlusion cause the performance of the signal timing to degrade. This is a common problem for most of the signals along Route 7 because the cameras are located on the far side of the intersection.

It is recommended that future VIDS application design be performed on a more detailed basis including the documentation of proposed camera positioning, anticipated view in static and video capture. This type of analysis can serve to point out issues such as occlusion, low sun light intrusion and others at the design stage.

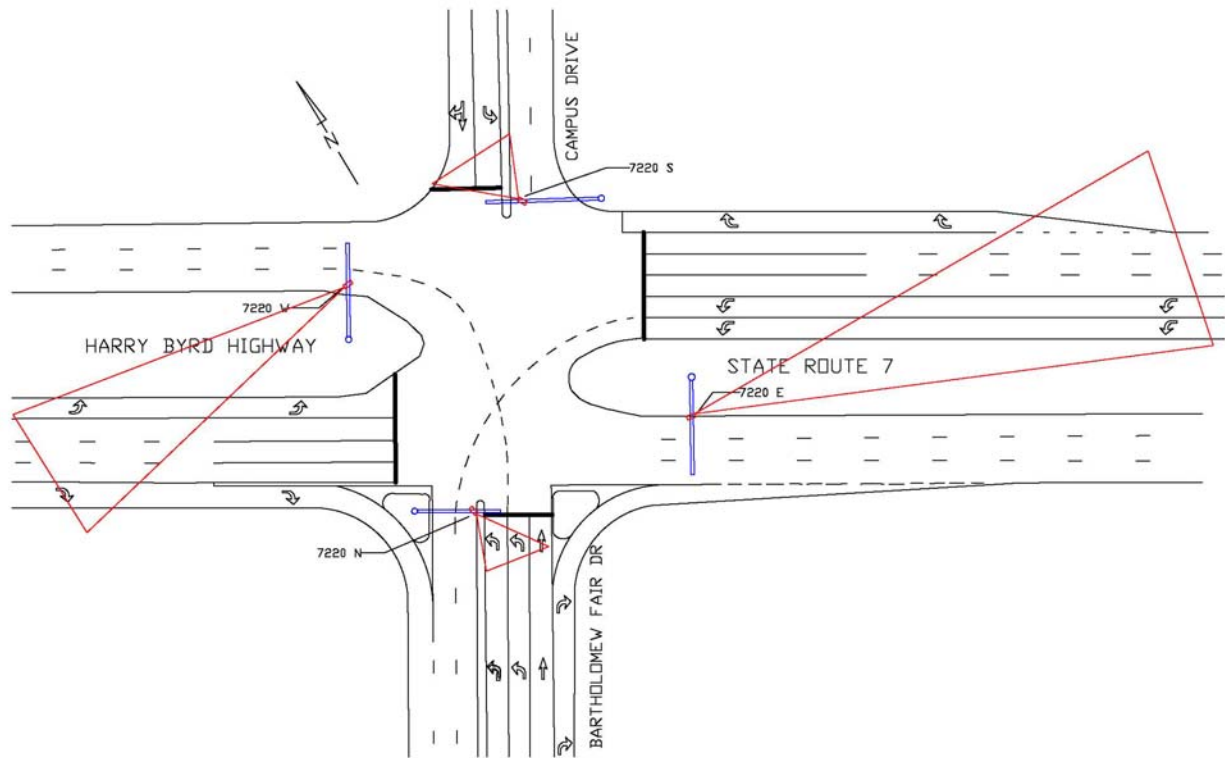
Figure 4: POSSIBLE SOLUTION - CAMERAS ROTATED 180 DEGREES

3. Occlusion issues occur frequently at the side street VIDS camera locations.

4. Sunrise and sunset low angle glare causes data errors for the mainline cameras on Route 7.

All 22 signalized intersections have far side VIDS camera for both east and westbound directions of the Route 7. Currently, the cameras are aimed and programmed to pick up traffic data at the Route 7 stop lines. The glare from the low angle of the sun during sunrise and sunset causes significant data errors.

Recommendation: Rotate the side street cameras 180 degrees horizontally and vertically with the camera pointing to the near side stop line (almost vertically looking down), (Figure 4). Reassign the cameras to the appropriate side street signal phase through software assignment in the signal controller. This realignment should mitigate the missed calls and occlusion on the side streets.

Recommendation: These issues will have to be addressed on an intersection-by-intersection basis, if these VIDS are to be used for any function. However, rotating the cameras 180 degrees horizontally and making using them for near side detection would provide some relief from the sun glare issues (Figure 4). This recommendation cannot be universally applied everywhere due to the variations in the vertical and horizontal alignments of Route 7.
